Manhole Inspection Summary

Manhole # S19GG2014MH

Insp Date: **9/19/06 1:42 PM**

Location Address: **1330 OLIVER ST**

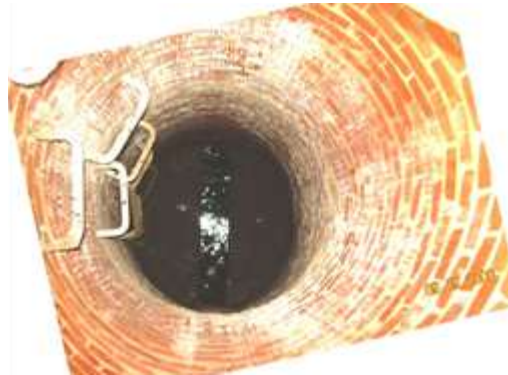
Top View

Corroded steps. Evidence of surcharge - Bench debris. Channel debris.

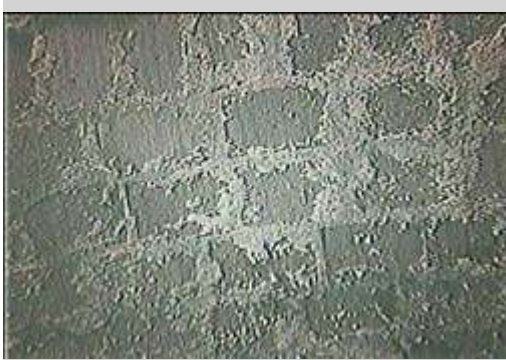
Defect

Infiltration: ☐ None ☒ Joint ☐ Cracks ☒ Mortar ☐ Roots ☐ Wall

Corbel infiltration.

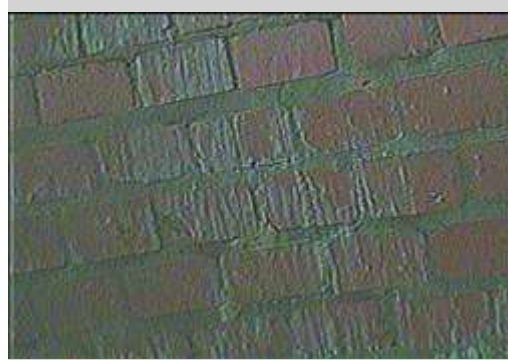
Defect

Infiltration: ☐ None ☐ Joint ☐ Cracks ☒ Mortar ☐ Roots ☒ Wall

Barrel infiltration.

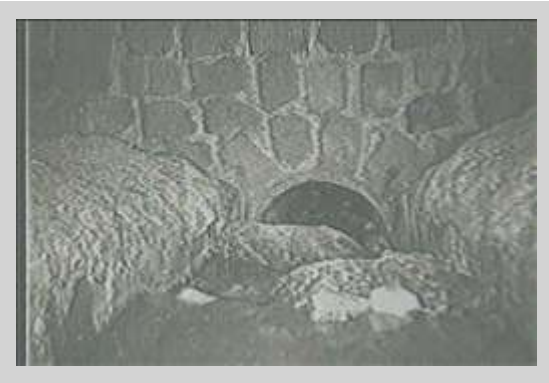
8 in. Circular Gravity Sewer Pipe Out @ 12 O'Clock

Deposits: ☐ None ☒ **Mud** ☐ Sludge ☒ **Debris** ☒ **Grease**

Silt Depth: **4** (in.) Deposits Extent: **Medium**

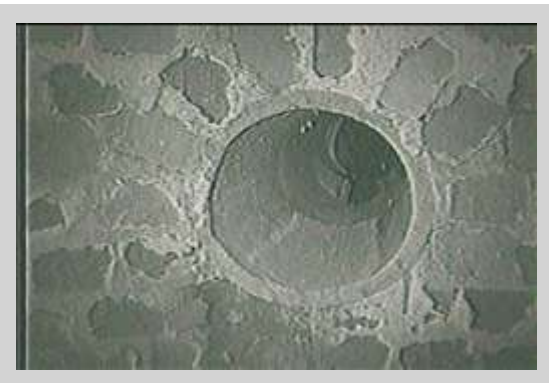
8 in. Circular Gravity Sewer Pipe In @ 6 O'Clock

Deposits: ☐ None ☐ Mud ☐ Sludge ☒ **Debris** ☐ Grease

Infiltration: **Evidence** Pipe Seal Cond: **Unknown**

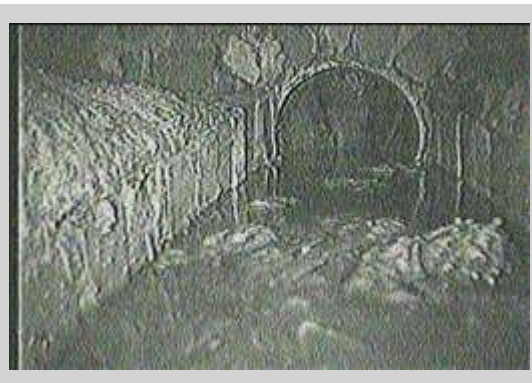
Drop In @ 6 O'Clock

Drop: **Outside** Rod and Bar

Drop Condition: **Open**
